## EGLACOM

*Evolution of a GLacial Arctic Continental Margin:  
the southern Svalbard ice stream - dominated sedimentary system*

# Cruise Report

*r/v OGS Explora, 08.07.08 - 04.08.08*

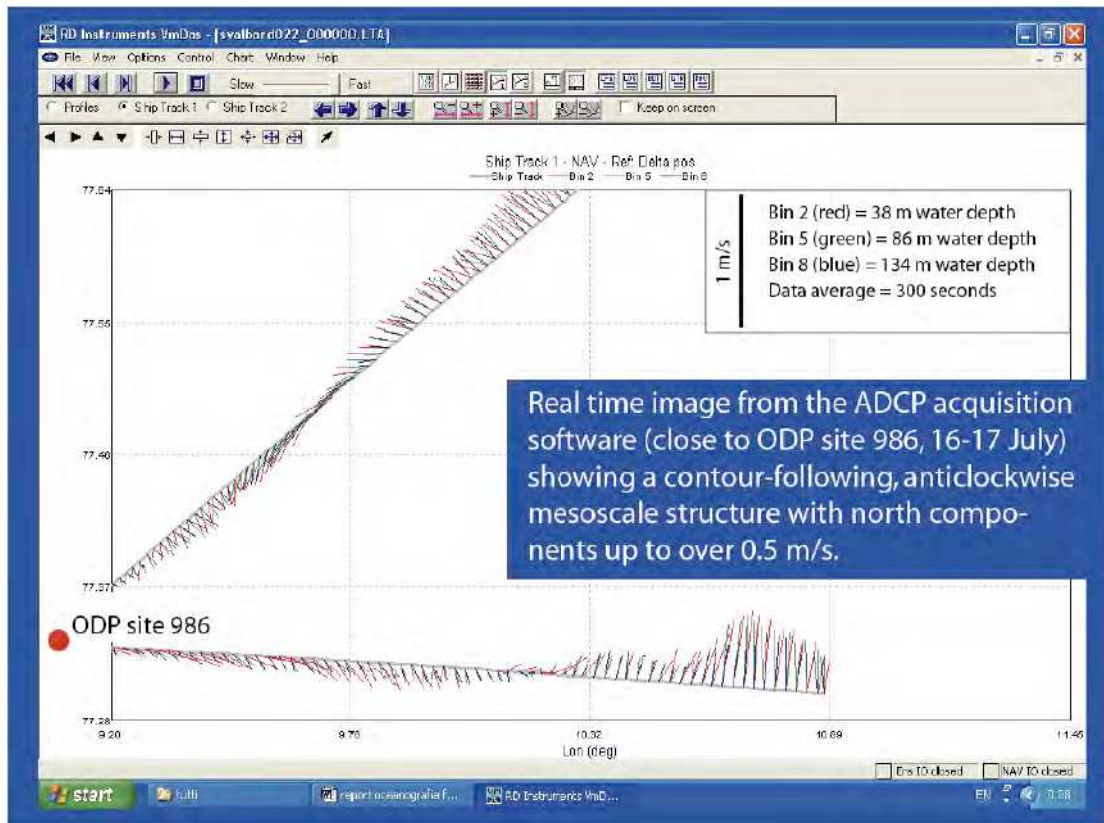
**Fig. 3.2.3. Example of ADCP data shown in real time by the acquisition software (location of ODP site and legend inserted with a drawing software).**

ADCP data were converted in matlab format and a preliminary analysis was performed. The methodology for correcting the raw data was calibrated using a first part of the data (see chapter 2.10 Problems and remedies). The next phases of processing will be performed during the subsequent post-cruise laboratory analyses.

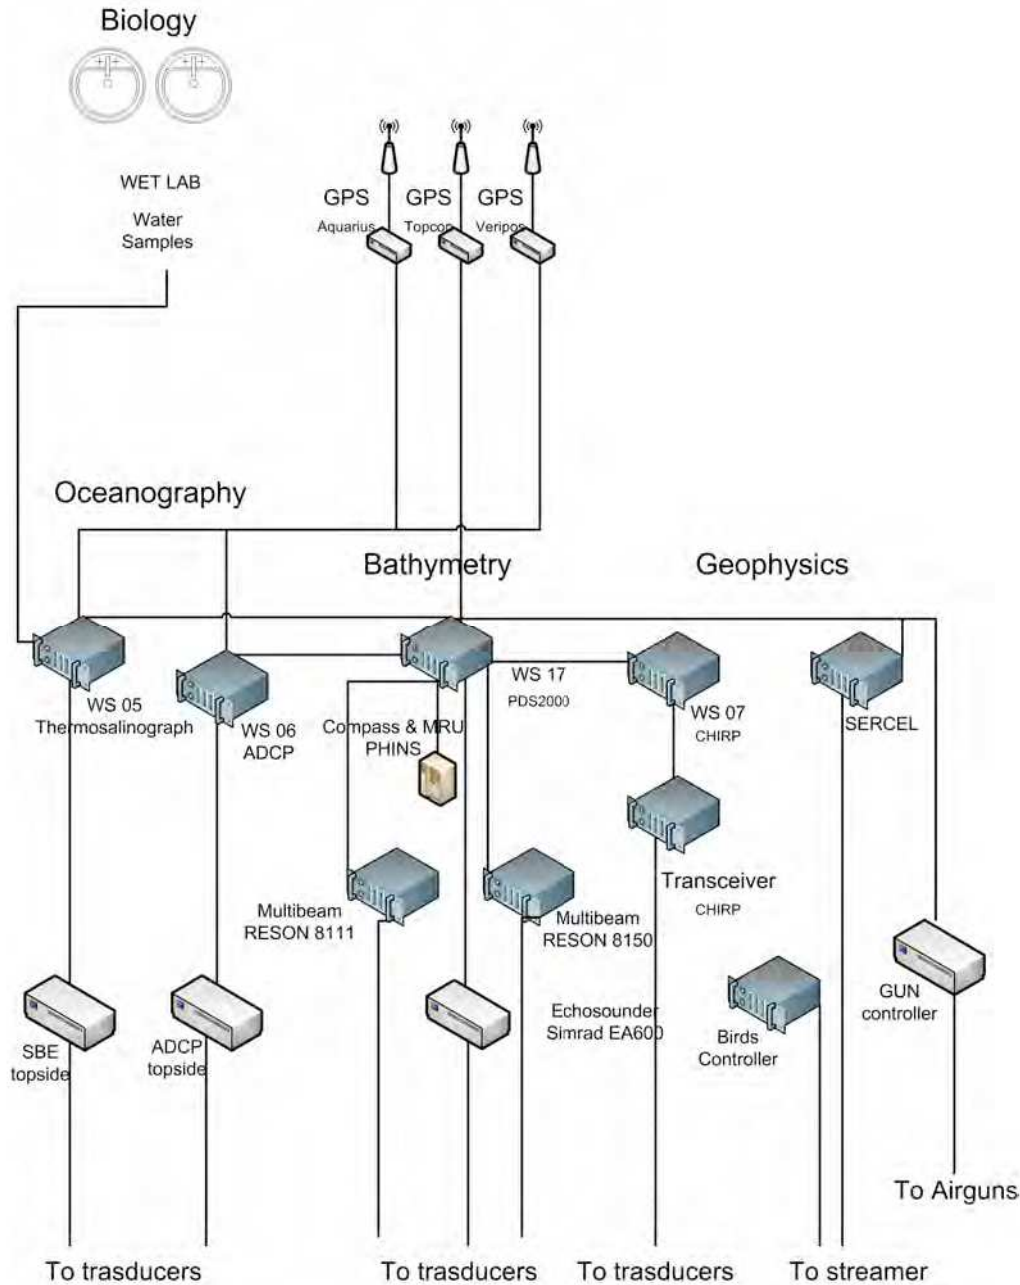
**Fig. B. 2: General equipment block diagram-**

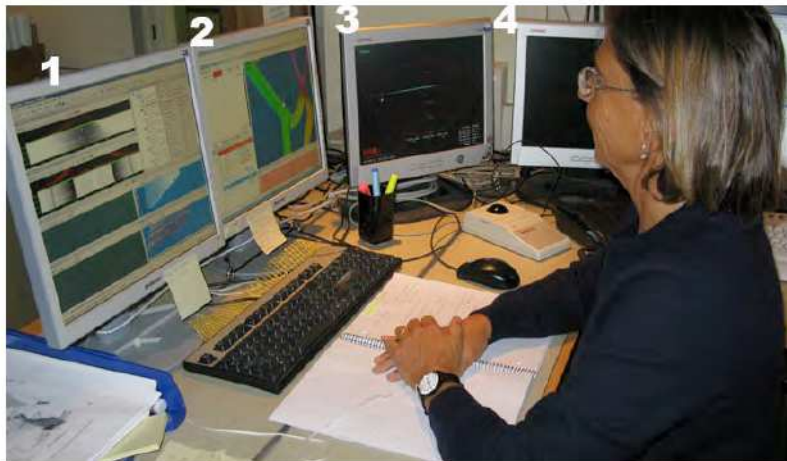
**Fig. B.3: Navigation room. The surveyor also operates the MBES by means of PDS2000 suite. Monitors shown in the photo: real time navigation and acquisition control (1 & 2), MBES control (3 & 4)**

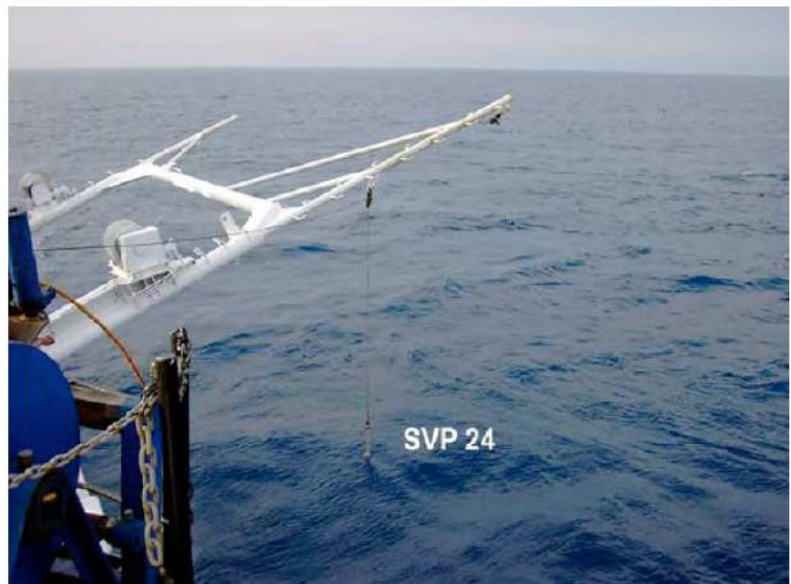
**Fig.B. 4: The Sound Velocity Probe is usually deployed by lowering the portside frame.**

Sound velocity profile measurements needed for real time correction of the incoming raw water depth data. They are supplied on a daily basis by means of a Sound Velocity Probe SVP-24, which also logs temperature measures along the water column. The probe is operated by a winch located on the second deck and placed in the sea by hanging it on to the portside lateral frame pulley. Alternatively, it can be deployed together with the CTD / WSC system.

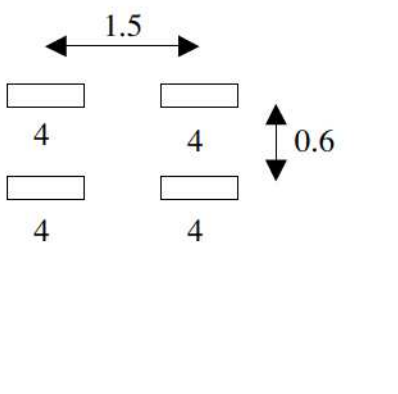
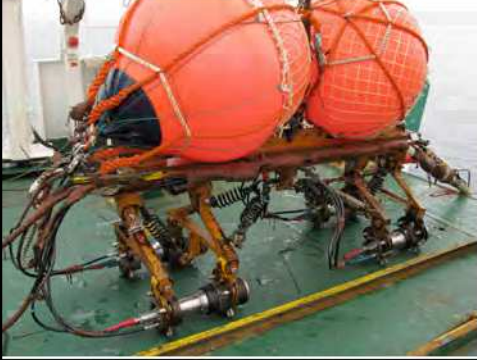
<p>The four guns are mounted on a metal frame. Shock absorption is provided by 6 springs.</p>	
THEORETICAL SIGNATURE AND SPECTRUM		
No of guns	4

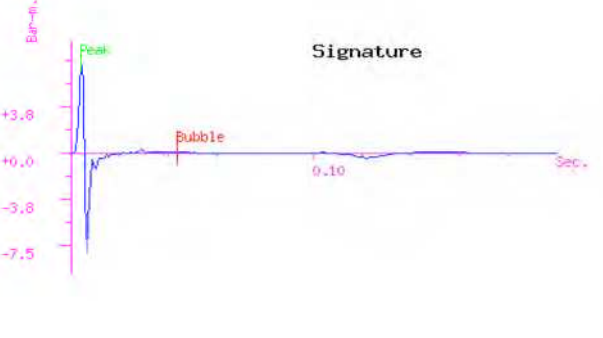
<p>Signature</p>
Total volume	160 cu.in	
Peak to peak	15.7 bar -m 1.57 MPa 244 db re 1 microPa at 1 m	
Zero to peak	7.54 bar -m 0.754 MPa 238 db re 1 microPa at 1 m	
Primary to bubble	33.9

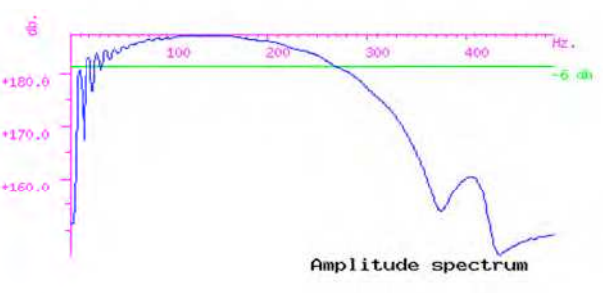
<p>Amplitude spectrum</p>
Bubble period to first peak	0.04 sec.	
Filters	Lo/slope -8.0 / 18.0 Hi/slope - 412 / 350	
Position	Infinite vertical far field	
<p>Note: Signature and spectra modelled by GUNDALF array modelling suite and provided by Fugro Oceansismica.</p>

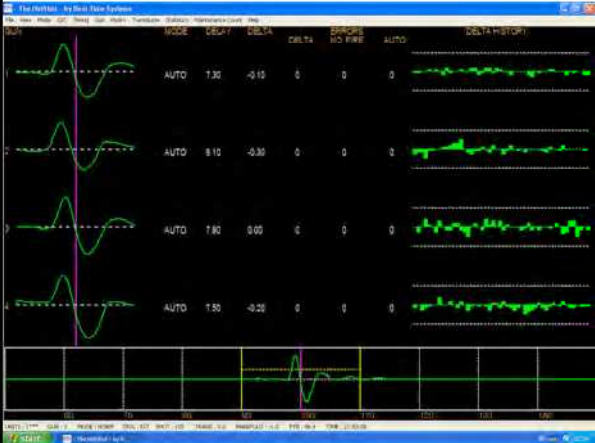
<p>Real time monitoring of guns synchronization. Each near field gun hydrophone output is displayed on the left hand side. The resulting near field signature is shown on the bottom. On the right hand side the delta quality history is displayed. Green histogram means that the shot time is within the desired tolerance (<math>\pm 1</math> ms).</p>

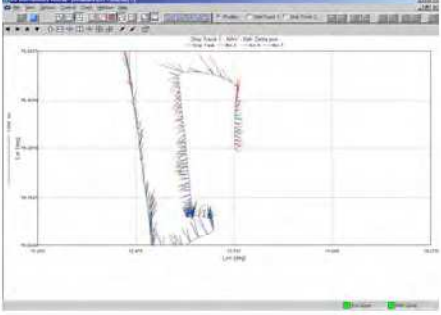
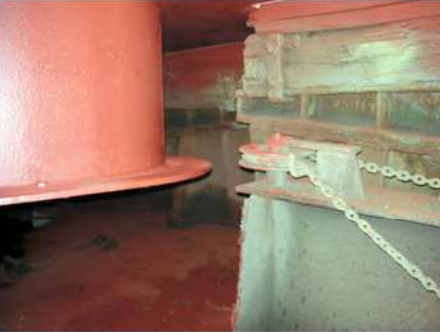
The transducers are permanently located on the vessel's keel (on the left in the picture)
Real time current profiles monitoring

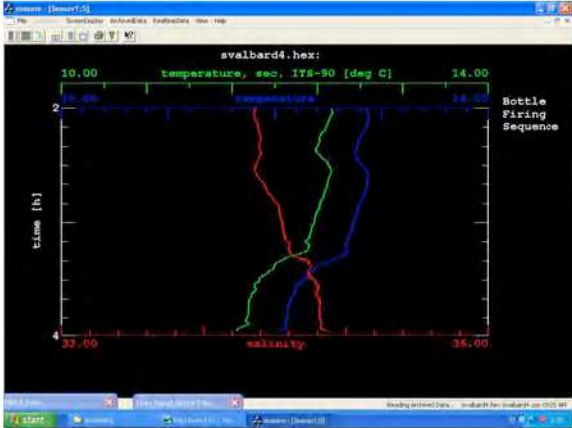
<p>Real Time monitoring of water physical parameters</p>

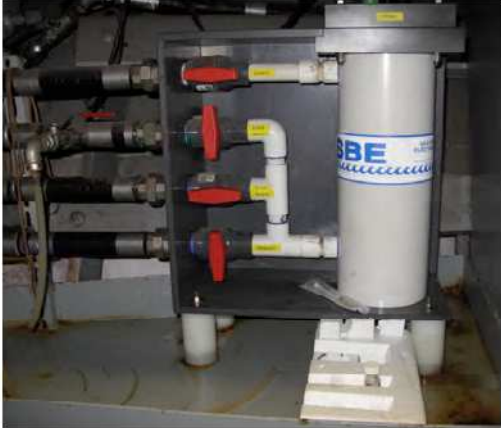
<p>The thermosalinograph is located in the hold of the ship</p>

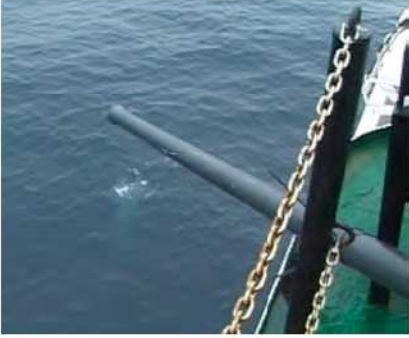
<p>The pipeline (made of a coiler liner and mounted near the winch control cabin) dedicated to XBT probe launch.</p>

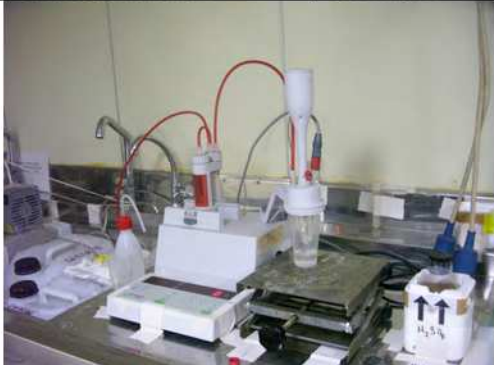
<p>Titration installed in the chemical-biological laboratory</p>
